FINAL SUMMARY OF HOUT BAY HOUSE RESEARCH PROJECT

Results of research focused on degradation of wood
in conditions of South Africa

Ing. Eliška Oberhofnerová, Ph.D.

Faculty of Forestry and Wood Sciences | Czech University of Life Sciences in Prague

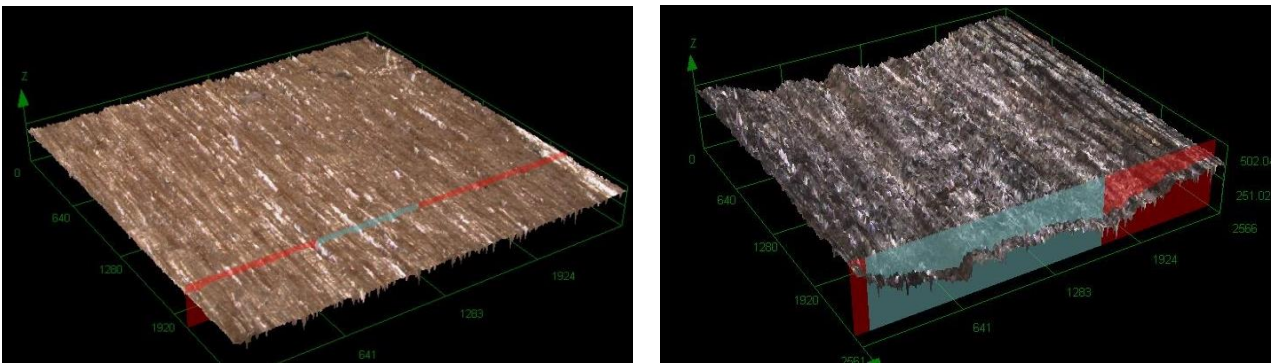
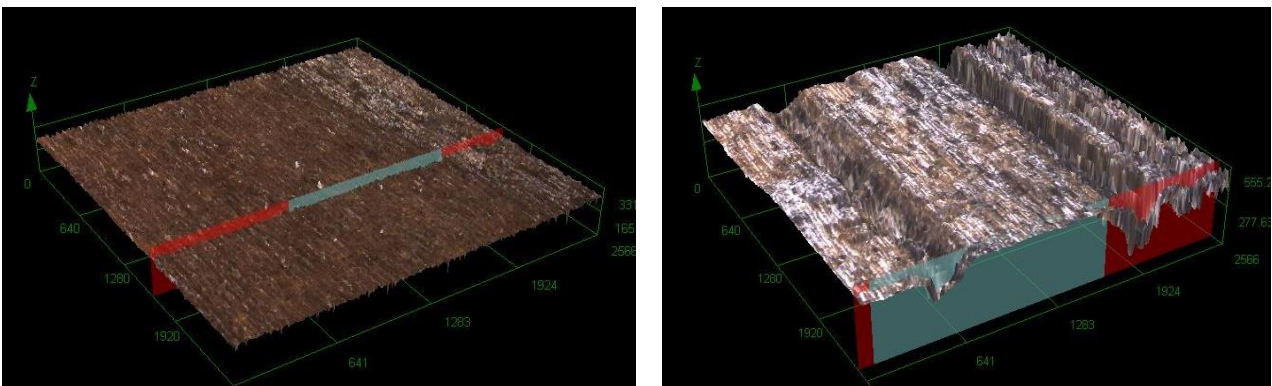
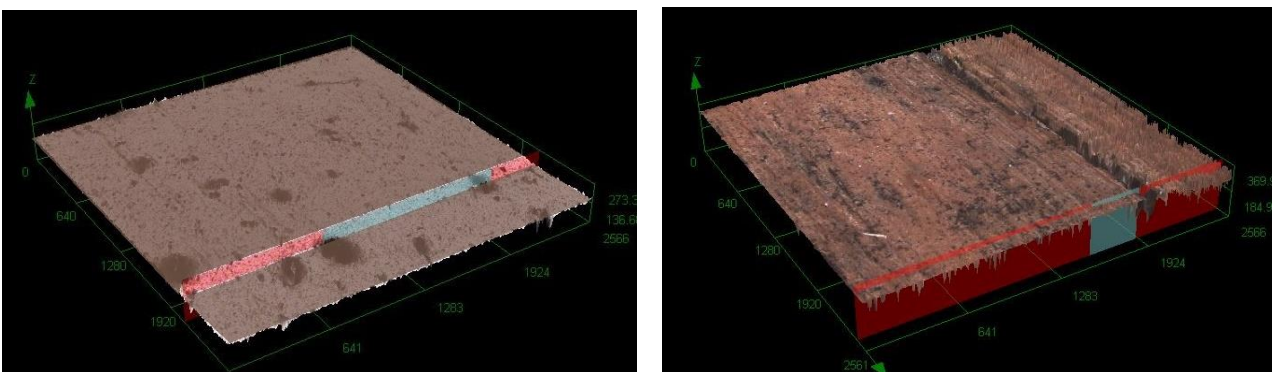
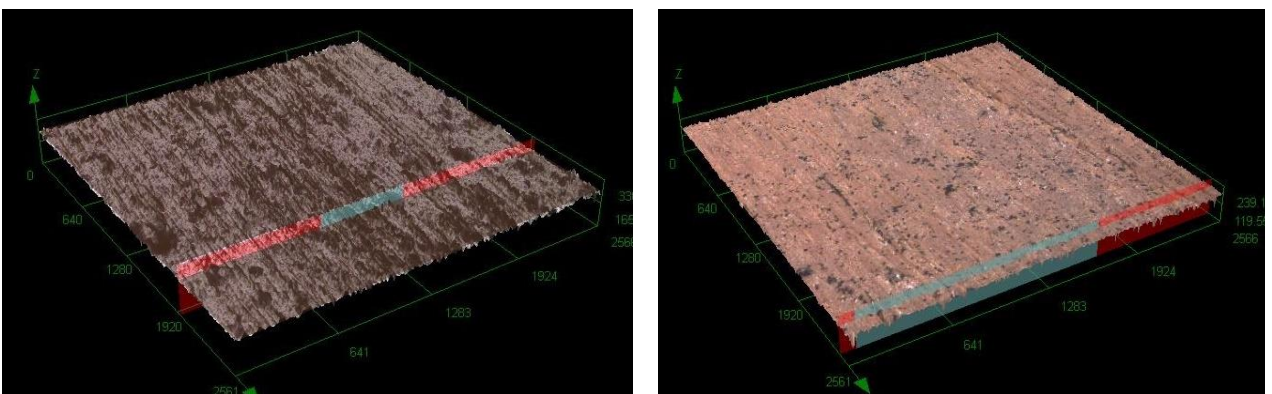
Figure 10: Laser scanning microscopy of samples before and after weathering

The laser scanning microscopy revealed visible greying of untreated wood caused by weathering, dust settling and formation of surface mould (Figure 10). Also degradation of surface treatment itself applied both on thermally modified pine and Siberian larch (flaking, chalking etc.) after 18 months of exposure was observed. In the case of treated Siberian larch, the degradation of coating is more significant. That was already proved by the evaluation of roughness change.

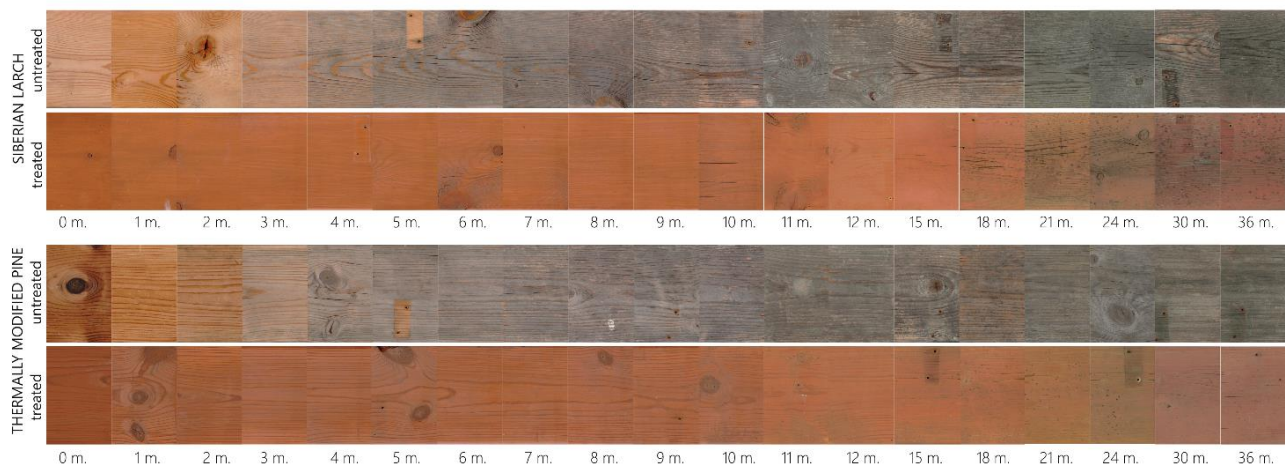
The samples were evaluated also visually (Figure 11). The visual evaluation basically confirmed the measured colour and roughness values. The high colour changes of untreated wood are visible already after 1 month of weathering. The greying is obvious approximately after 4 months of weathering of untreated samples. The formation of cracks which basically ran in the direction of wood fibres was observed on untreated samples during weathering. The degradation of coating started approximately after 12 months of exposure and led to the final peeling and cracking of applied layer, which was more obvious in the case of treated Siberian larch.

Figure 11: The appearance of test samples during 0 – 36 months of natural weathering (from the top line: Siberian larch untreated and treated, thermally modified pine untreated and treated).

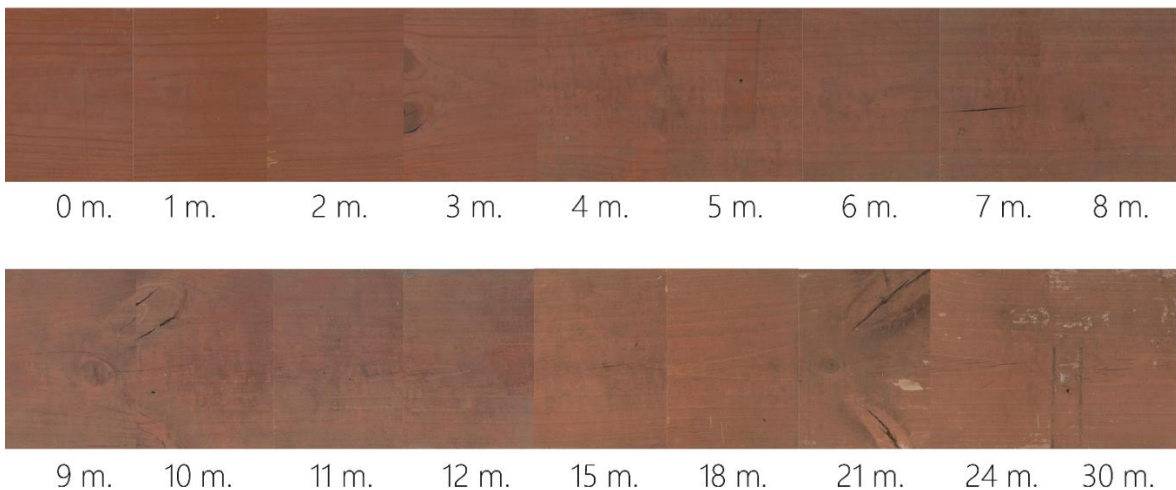
Figure 13: Visual appearance of pre-weathered pine during 0-30 months of weathering

From the evaluation of visual appearance of pre-weathered pine during 0-30 months of weathering (Figure 13), the gradual wood degradation of coatings can be observed. The coating started to degrade basically after 12 months of exposure, the peeling started approximately after 18 months of natural weathering. The total colour changes were higher in the comparison with the samples which were not pre-weathered. From that point, the initial pre-weathering did not improve the wood properties associated with coating application and weathering.

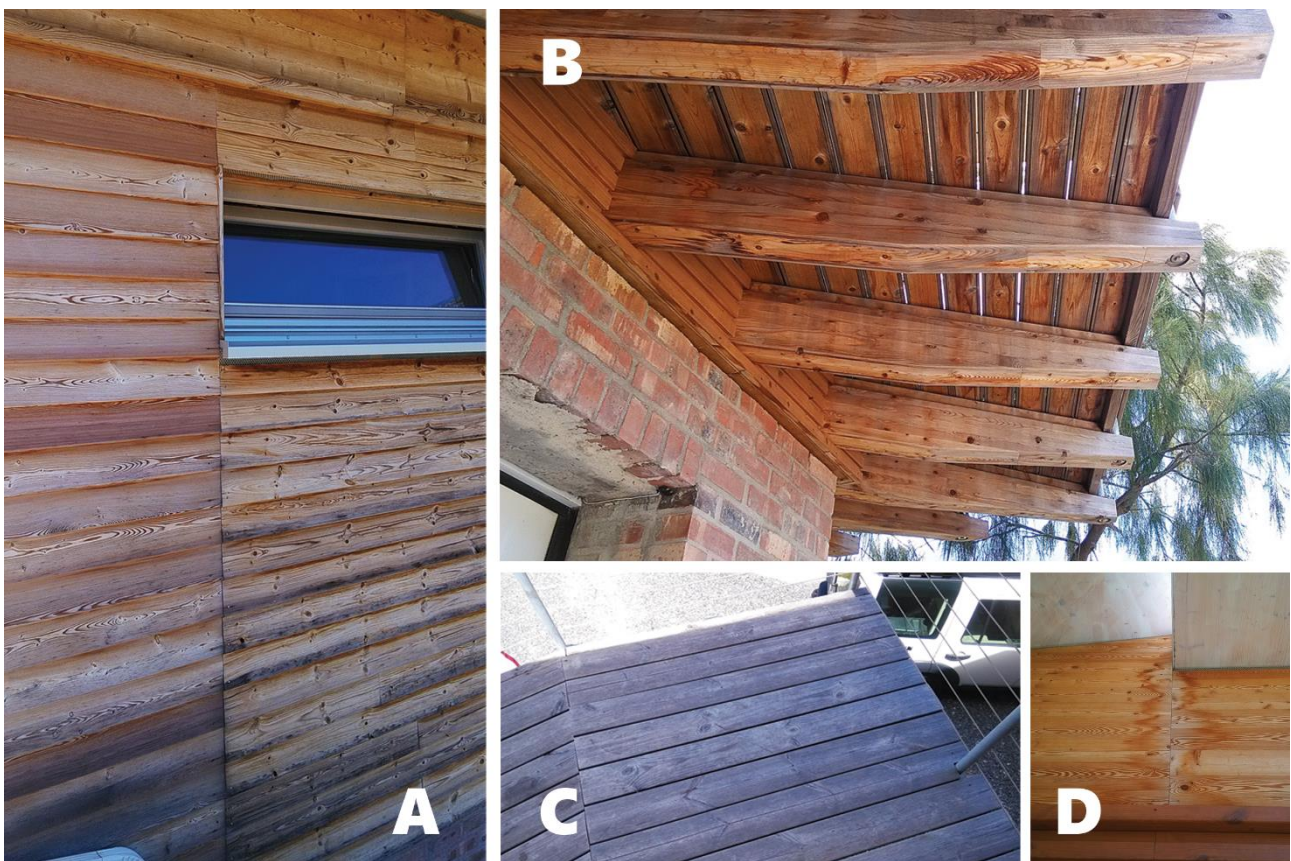
Visual appearance of wood constructions (façade cladding and terrace decking) in the case of Hout Bay House was evaluated (Figure 14). The façade with untreated cladding from Siberian larch and untreated thermally modified pine degrades unequally, since the profiles cover each other and the rain reaches only the lower parts of profiles (Figure 15, Figure 16). Also the effect of roof overhangs is visible – wood under it turned yellow, not grey, as a result of solar radiation effect. Every protrusion causes unequal discolouration. It is not a mistake of a construction or material, but we have to consider that when we design untreated façade. In the case of treated façade, there is also a change of colour which is more apparent in the lower parts of façade – as an effect of roof overhangs. The surface is significantly less glossy and cracks started to appear. The terrace decking is significantly more exposed to weathering than cladding. The untreated terrace is grey and rough after 30 months of weathering. It degraded equally. But once this grey surface is formed, further degradation is slow to develop. We can conclude from the experiments done, that the Siberian larch tends to be more susceptible to cracking than thermally modified pine in the case of wood decking and it has a tendency to increased formation of splinters.

Figure 14: The appearance of wood constructions after 30 months of weathering: visual signs of wood degradation (degraded untreated wood untreated façade with unequal discolouration (A), discolouration and leaching of untreated larch (B), greying of terrace from untreated thermally modified pine (C), leaching of lignin and extractives by water (D)).

The real built wood construction at HBH were characterized with unequal greying, roughening and cracking in the case of untreated wood. The treated constructions were noted for slight discolouration and loss of gloss. The decking was significantly more affected by weathering than wooden cladding covered by roof overhangs.

In conclusion, currently the trend of using treated or even untreated wood elements in the exterior is becoming more progressive. But wood is a natural material and it behaves accordingly. Basically we have two options - we can either accept the fact that untreated wood eventually turns grey (in the most cases unequally) and gets typical plastic structure, or we can apply suitable surface treatment which will prevent the wood from greying and roughening, but which has to be renewed after several years.

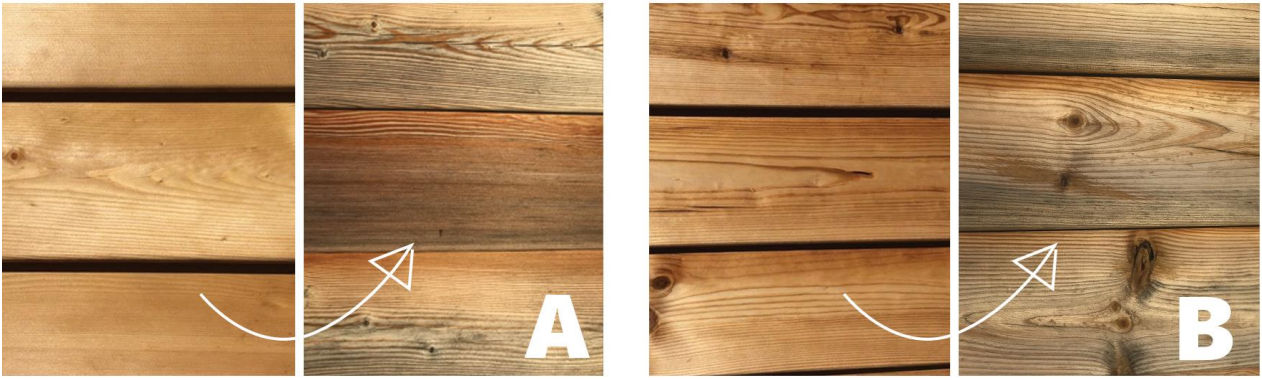
Figure 15: The appearance of wood constructions before and after 30 months of weathering: façade from Siberian larch untreated (A) and façade from thermally modified pine untreated (B)

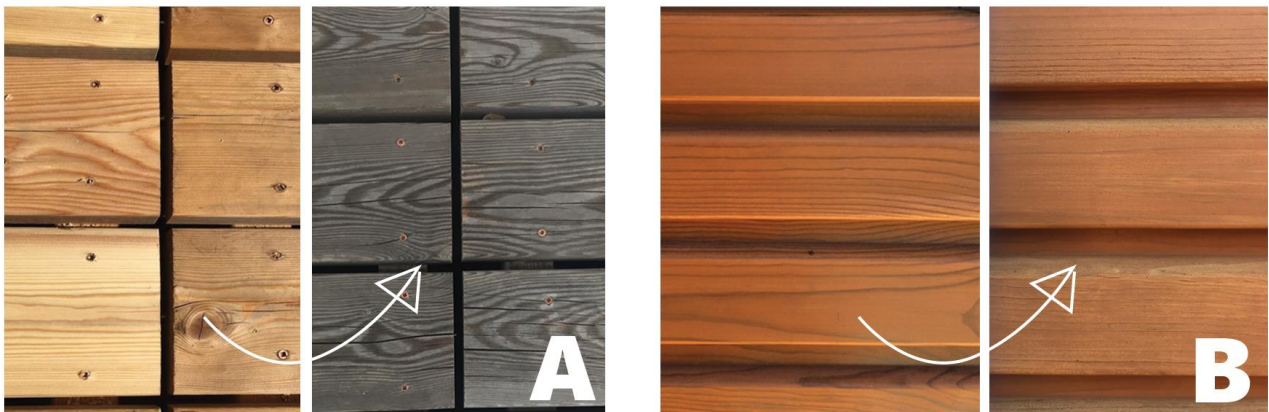
Figure 16: The appearance of wood constructions before and after 30 months of weathering: terrace from untreated Siberian larch (A) and façade from treated thermally modified pine (B)
