# SUMMARY OF HOUT BAY HOUSE RESEARCH PROJECT

Progress in Hout Bay House research project: Thermal properties and wood degradation

Ing. Eliska Oberhofnerova

Czech University of Life Sciences in Prague

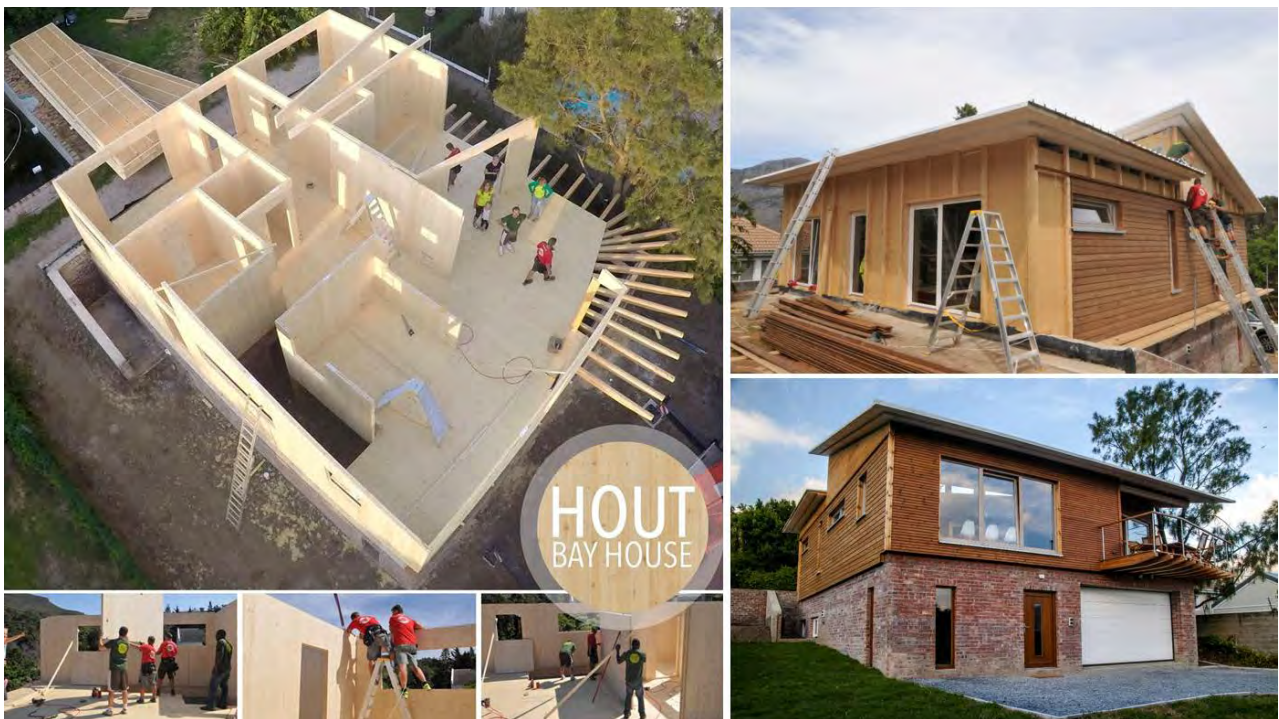
Hout Bay House is located in Western Cape which is known for coastal and windy conditions. The design of house uses the newest technologies in the wood industry with the respect to basic construction solution increasing the durability of wood and whole service life of a building. The construction of the house is made of the lower brick and mortar part and upper wooden part (Figure 1). For the load bearing wall construction the 84 mm thick NOVATOP solid wood panels based on cross laminated spruce timber were used. The walls were insulated by wood fibre insulation Pavatex (bulk density 145 kg/m<sup>3</sup>) with the thickness of 80 mm (west façade) and 120 mm. The external layer is created by the wooden facade (Siberian larch and thermally modified pine) held by the spruce grid with ventilated air gap with the thickness of 60 and 100 mm, respectively. In some parts of the interior the Novatop layer is covered by Fermacell gypsumfibre boards. The roof consists of open NOVATOP elements filled with thermal insulation with roof overhangs and covered by metal sheets.

Figure 1: Hout Bay House and its construction

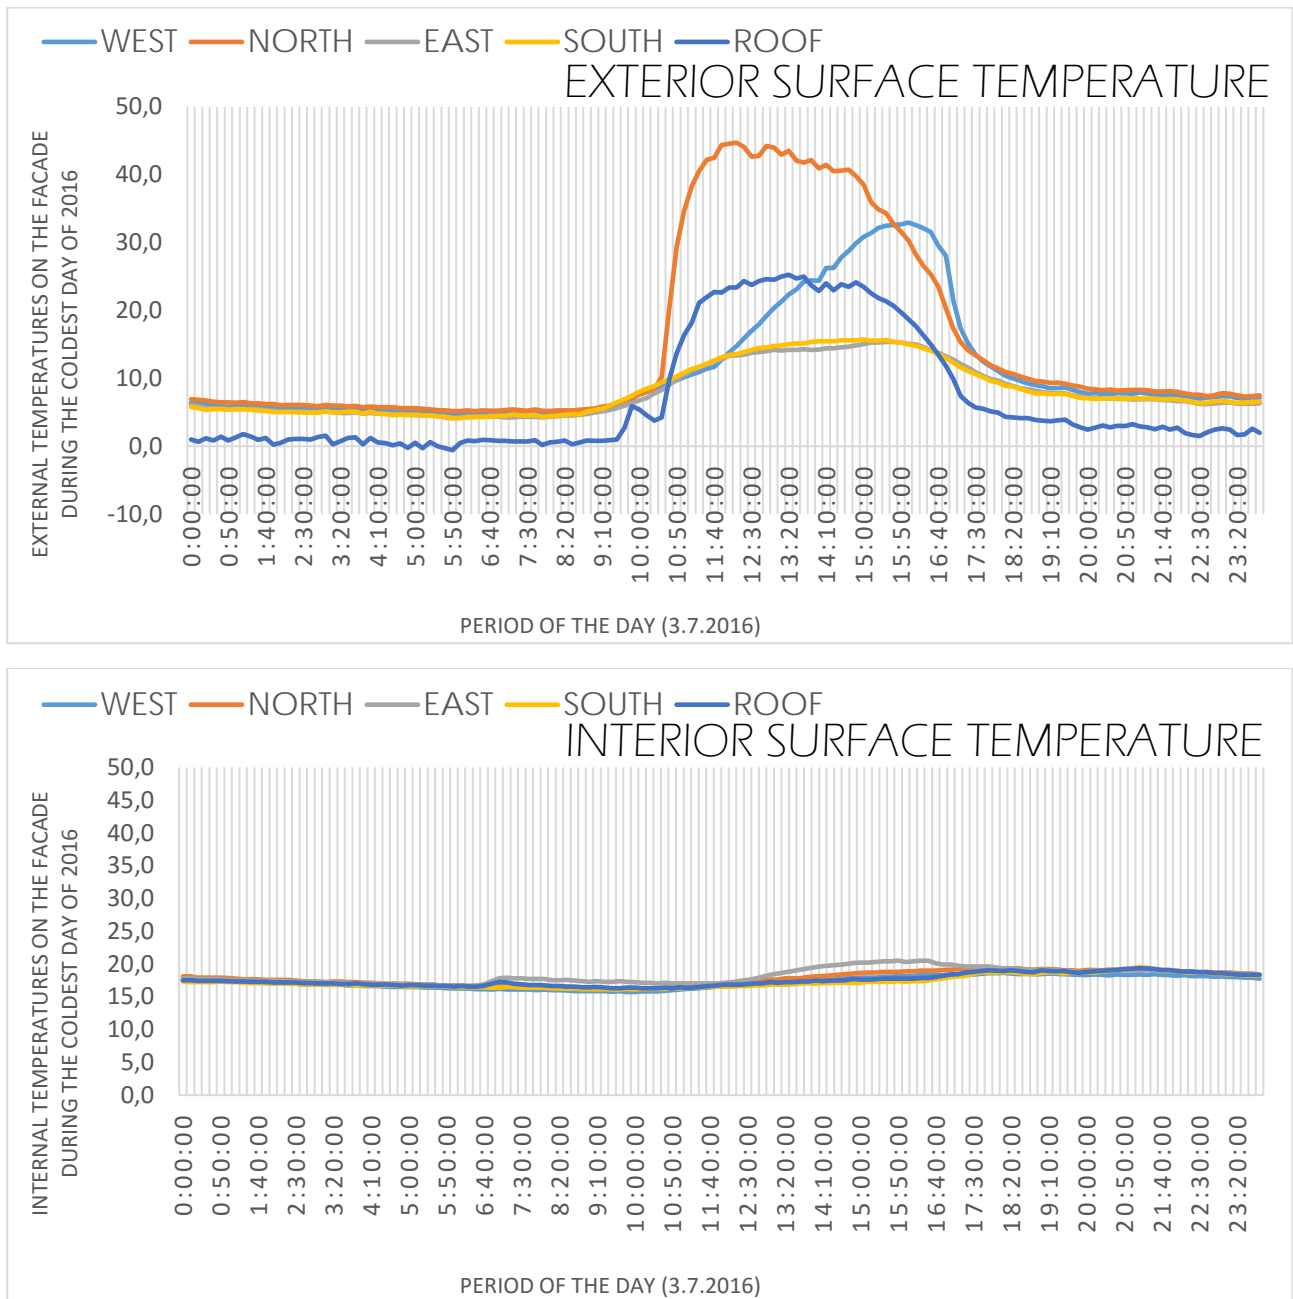
The graphs show exterior surface temperatures of house according to different orientation (Figure 8). The obvious fluctuations which did not reflect into the interior surface temperatures – which show the graphs below not even in the case of west side with 8 cm of insulation. The wall construction is able to resist a heat flow which goes always from the place with higher temperature to place with lower temperature.

Figure 8: Surface temperatures based on the orientation during the coldest day of 2016

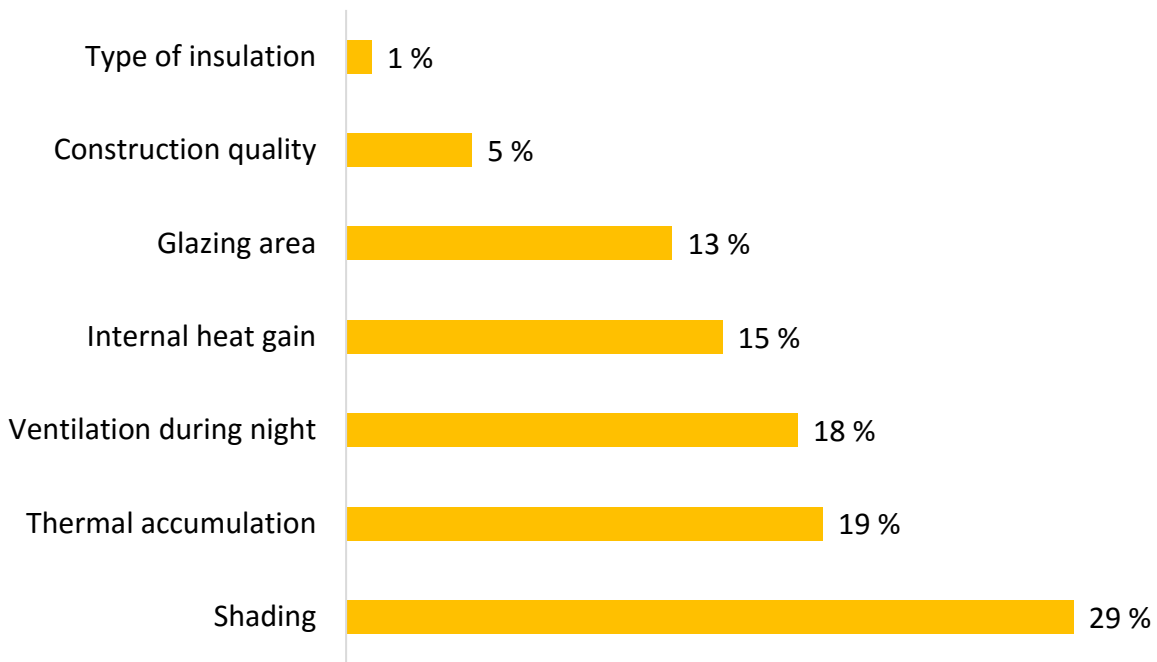
To sum up the results, during winter, heat losses are minimized by the quality and **thickness** of thermal insulation, quality of windows and whole **airtightness** of the building. During summer, there is an actual danger of possible overheating during summer in South Africa (**large windows, airtightness**). There is a list of factors influencing overheating according to EMPA (Swiss Federal Laboratories for Materials Science and Technology) as shading, ventilation, glazing area, thermal accumulation etc. (Figure 11). The intensity of ventilation can effect the temperature in the interior by 4,5 °C and the shading by 3 °C. In the case of Hout Bay House, the house is overheated probably because of large windows without shading.

Figure 11: Factors influencing the overheating of the house

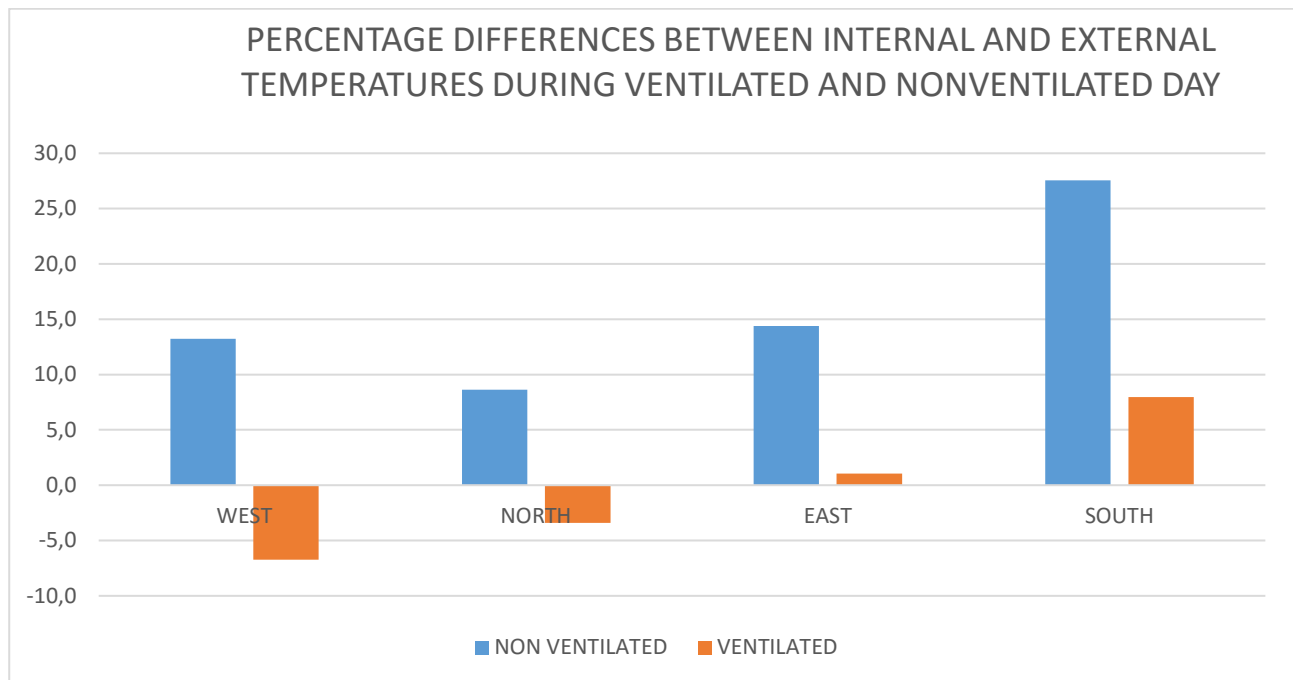
The effect of natural ventilation during summer day is demonstrated in following graph (Figure 13). Since the house is really airtight, we have to ventilate to cool it down and get fresh air. For this reason we compared two days – with and without the natural ventilation during the summer day. When there was no ventilation, the interior temperatures were higher than in exterior up to 27 %. When the house was naturally ventilated during the summer day, the interior temperatures were

lower or does not exceed the 8% increase of temperature according to orientation. There is a visible decreasing effect of only natural ventilation on the temperature in the interior.

Figure 13: The effect of natural ventilation on the temperature in interior

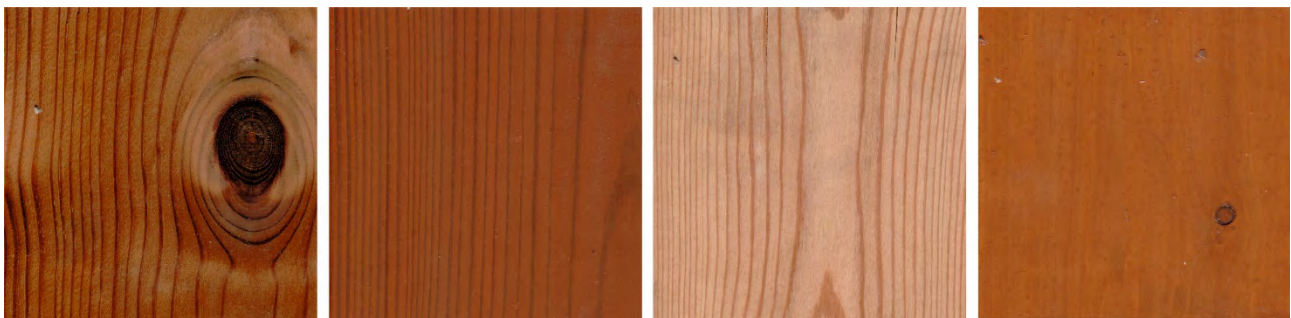
The Siberian larch wood and thermally modified pine, in European conditions considered as durable, were selected for the façade cladding and terrace decking at Hout Bay House (Figure 14). Larch has high resistance to climatic factors but without a suitable surface treatment it tends to turn grey and crack. Thermally modified pine wood has been produced by controlled process during which was the wood being exposed to high temperatures in range of 185-215 °C. This material is generally considered to be very durable with regard to given climatic conditions and does not undergo substantial dimensional changes. It is also noted for increased resistance to rotting and cracking. The test samples were prepared, one part of them was left untreated, the other part was treated with 2 layers of natural oil wood stain UV OSMO.

*Figure 14: Test samples (from left: thermally mod. pine untreated and treated, Siberian larch untreated and treated)*

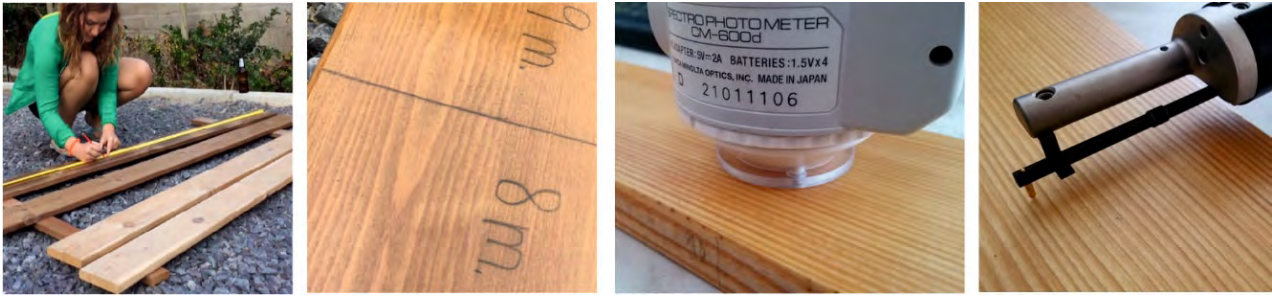
These samples were exposed to natural weathering in special stands facing north in the inclination of 45° according to European standards. The test samples were cut off from the exposed elements and evaluated on the basis of change of colour, gloss, roughness, wettability and other visual properties during three years of exposure, monthly in the first year of the research (so far 18 months), then in longer periods (Figure 15). In addition, the degradation process of wooden façade and terrace was also regularly visually evaluated.

Figure 15: The test samples marking and measurements using spectrophotometer and profilometer.

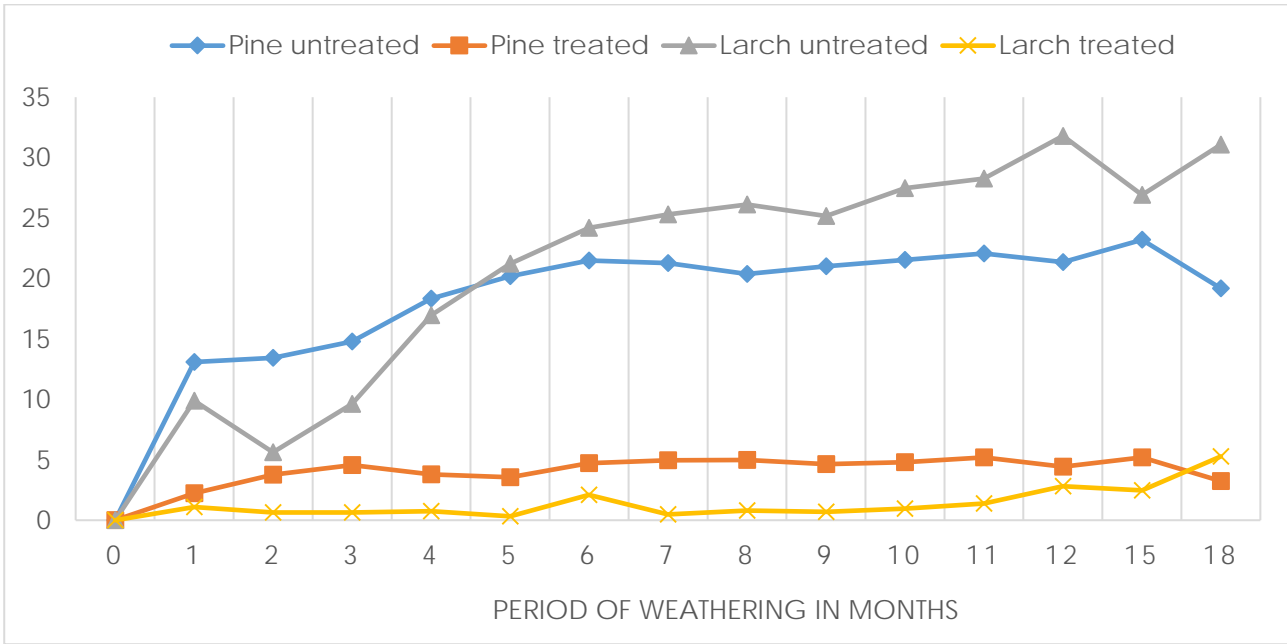
Figure 19: Total colour difference of tested samples during weathering

The graph shows a trend when surface treated samples showed significantly lower colour changes and stable results during 18 months of outdoor exposure (Figure 19). On the contrary, high colour changes were observed even after 1 month of exposure on the surface of untreated wood (both thermally modified pine and Siberian larch). The total colour difference of thermally modified pine increased during exposure. Regarding the untreated Siberian larch it is possible to observe the trend of large increase in the colour difference after the first month and the drop after other two months. This can be due to the degradation of lignin and extractives caused especially by UV radiation. Thus disturbed photo-degradation products are washed out from the wood surface and significantly affect the colour change, the colour turns yellow first, then gradually darkens and turns grey. The overall lowest colour difference was observed for treated samples – colour changes visible with the medium quality filter (Table 1), the highest for untreated larch after 18 months of weathering – different colour according to Table 1. Generally, the total colour difference of all treated and untreated samples increased with increasing exposure period in natural weathering.

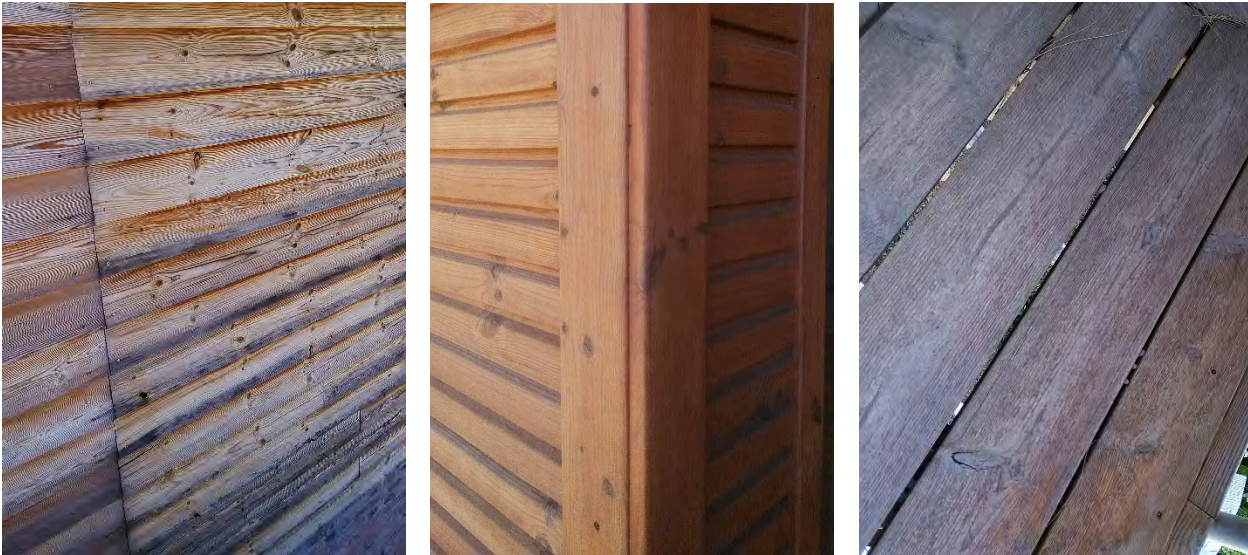
Visual appearance of wood constructions (façade cladding and terrace decking) in the case of Hout Bay House was evaluated (Figure 24). The façade with untreated cladding from Siberian larch and untreated thermally modified pine degrades unequally, since the profiles cover each

other and the rain reaches only the lower parts of profiles. Also the effect of roof overhangs is visible – wood under it turned yellow, not grey, as a result of solar radiation effect. Every protrusion causes unequal discoloration. It is not a mistake but we have to consider that when we design untreated façade. In the case of treated façade, there is also a change of colour which is more apparent in the lower parts of façade – as an effect of roof overhangs. The surface is significantly less glossy and cracks started to appear. The terrace decking is significantly more exposed to weathering than cladding. The untreated terrace is grey and rough after 2 years of weathering. It degraded unevenly. Once this grey surface is formed, further degradation is slow to develop. The Siberian larch tends to be more susceptible to cracking than thermally modified pine in the case of wood decking.

Figure 24: The appearance of wood constructions after 2 years of weathering: untreated facade, treated facade and terrace decking (from left to right)
