FINAL SUMMARY OF HOUT BAY HOUSE RESEARCH PROJECT

Results of research focused on degradation of wood
in conditions of South Africa

Ing. Eliška Oberhofnerová, Ph.D.

Faculty of Forestry and Wood Sciences | Czech University of Life Sciences in Prague

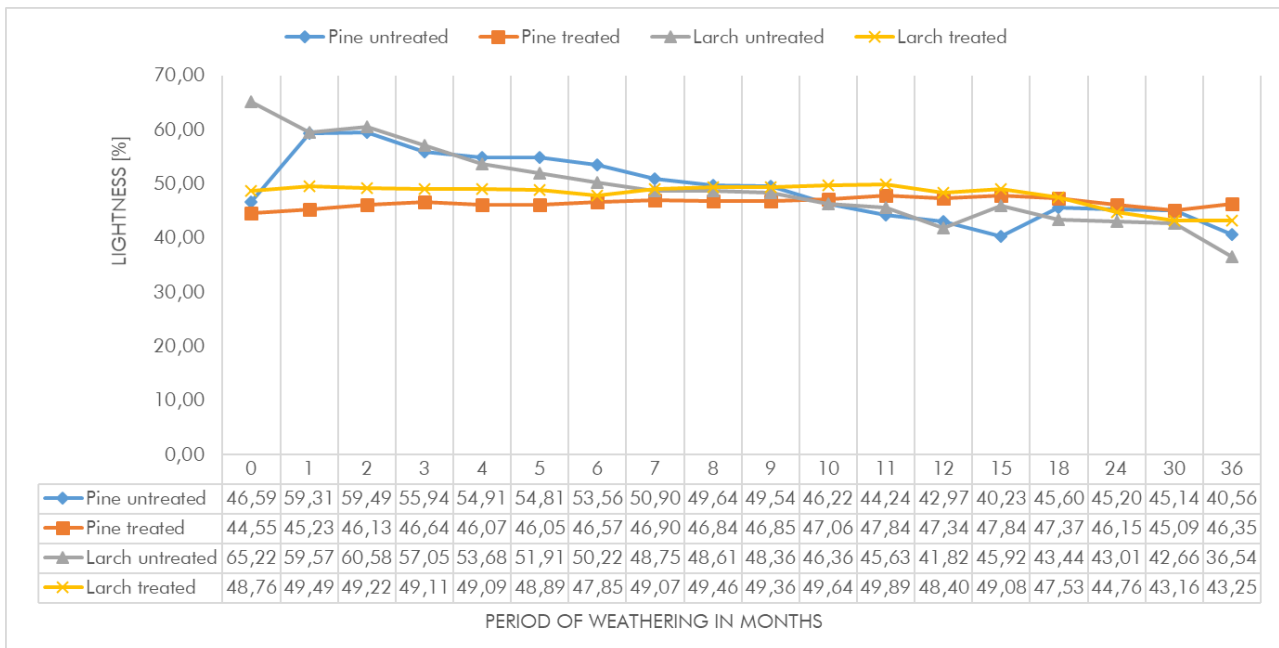
Figure 4: Change of lightness parameter during weathering

The results confirmed that in the early stages of weathering, dark wood tends to become light and light wood becomes dark according to lightness parameter values (Figure 4). The values a* and b* of untreated samples followed a similar trend shown in previous studies, increased at the beginning of weathering and then decreased in the case of untreated samples (Figure 5, Figure 6). The changes in a* values are determined mainly by the changes of the chromophore groups in extractives. The initial increase in b* values indicates the degradation of lignin. The final decrease of yellowness of untreated samples may be attributed to leaching of decomposed lignin and extractives by water. Overall, the colour parameters of treated wood had more stable results without any important fluctuations in comparison with untreated wood.

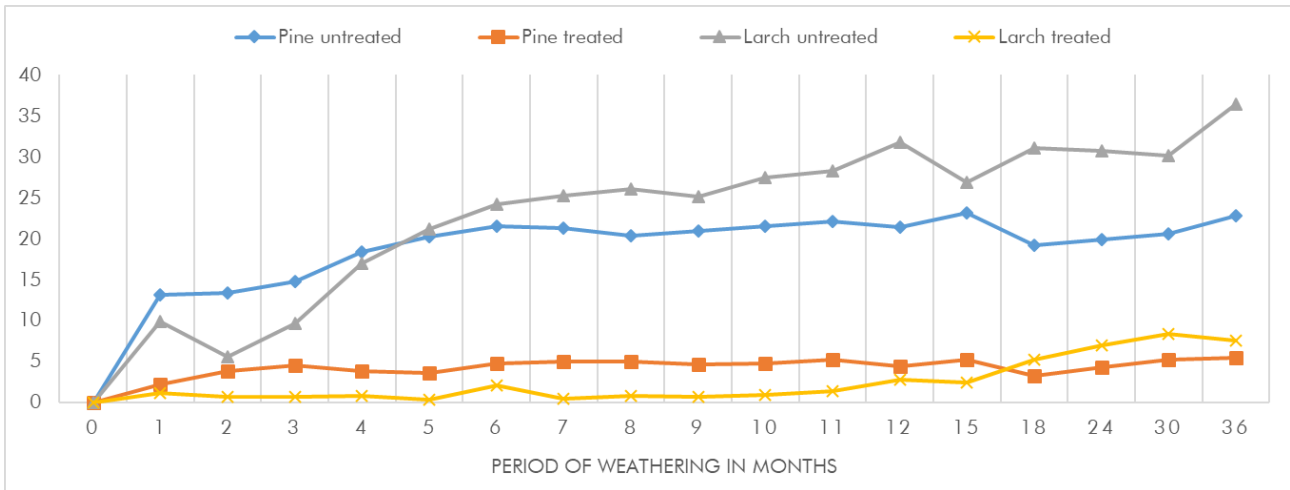
Figure 7: Total colour difference of tested samples during weathering

The graph shows a trend when surface treated samples showed significantly lower colour changes and stable results during 36 months of outdoor exposure (Figure 7). On the contrary, high colour changes were observed even after 1 month of exposure on the surface of untreated wood (both thermally modified pine and Siberian larch). The total colour difference of thermally modified pine increased during exposure. Regarding the untreated Siberian larch, it is possible to observe the trend of large increase in the colour difference after the first month and the drop after other two months. This can be due to the degradation of lignin and extractives caused especially by UV radiation. Thus, disturbed photo-degradation products are washed out from the wood surface and significantly affect the colour change, the colour turns yellow first, then gradually darkens and turns grey. The overall lowest colour difference was observed for treated samples – colour changes visible with the medium quality filter (Table 1), the highest for untreated larch after 36 months of weathering – different colour according to Table 1. Generally, the total colour difference of all treated and untreated samples increased with increasing exposure period in natural weathering.

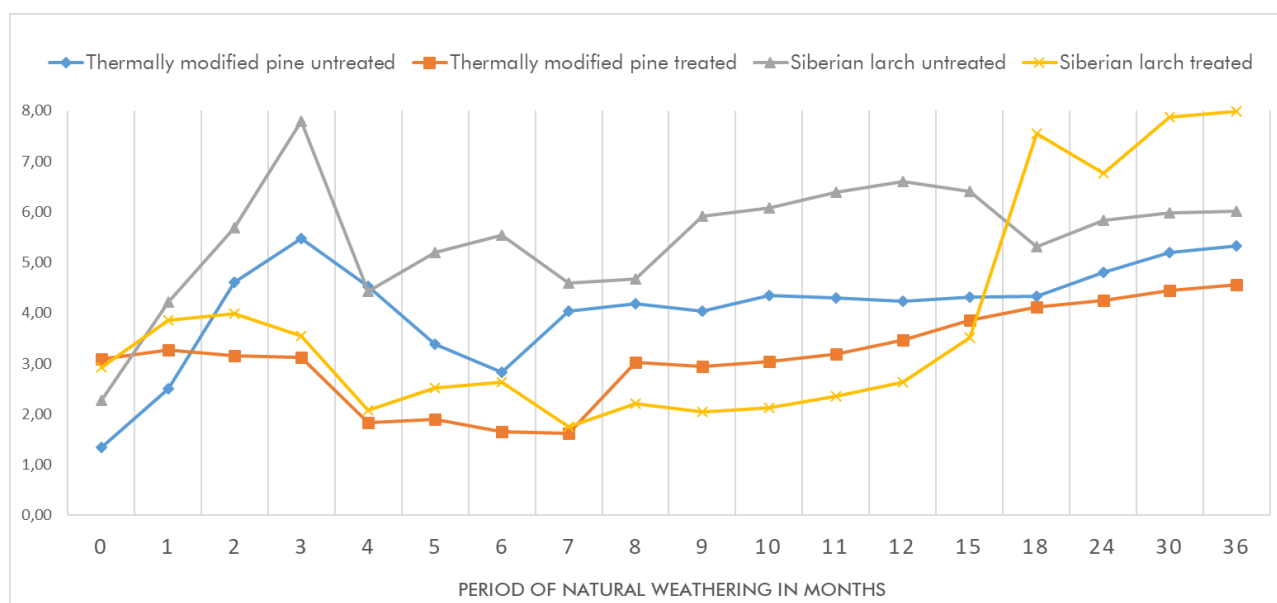
Figure 8: Change of roughness during weathering

The treated samples show a comparable stable results during the 15 months of exposure (Figure 8). After 15 months of exposure, the surface treatment started to degrade. It is obvious from the increased roughness value after this period of weathering, especially for the coating applied on Siberian Larch, which was more degraded in comparison with treated pine. For untreated wood species a high increase in surface roughness can be observed mainly in the beginning of weathering. This trend can be explained by leaching of the products of photo-degradation reactions (lignin, extractives, as well as hemicellulose), which can lead to the tearing of cellulose fibres exposed on the wood surface. The arisen degraded surface is later filled with dust particles and decomposed products which leads to greying and smoother surface. The little fluctuations are rather caused by variability of wood than any significant trend.

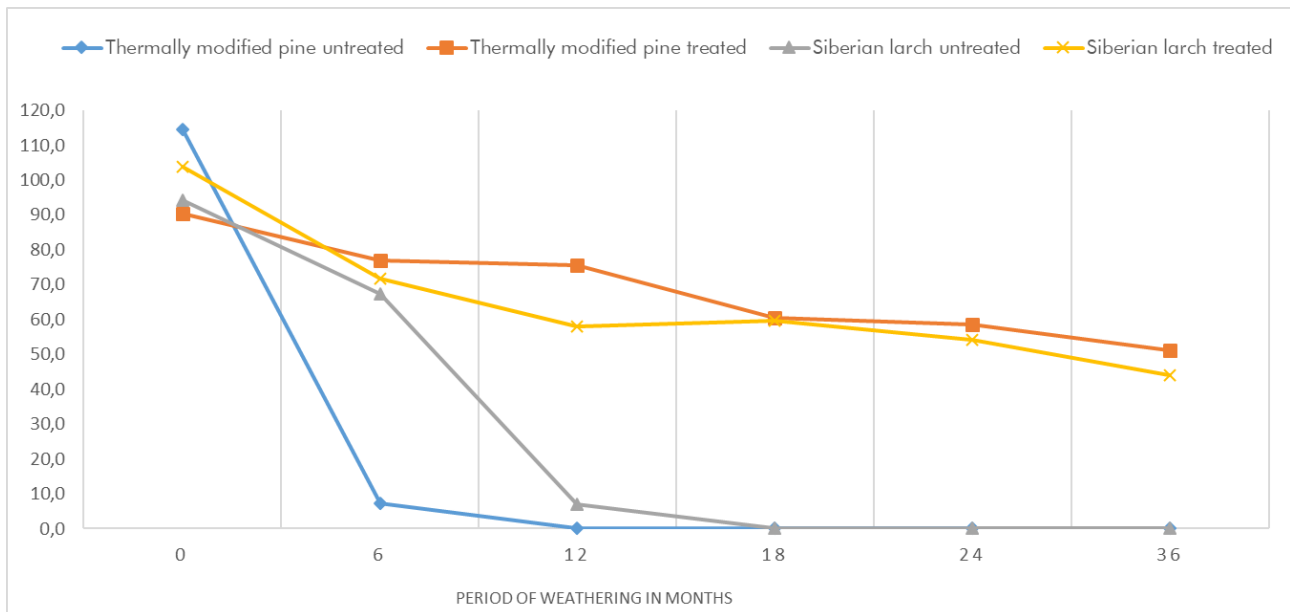
Figure 9: Change of wettability during weathering

This graph shows a change of surface wetting during exposure – which express the ability to absorb water (Figure 9). In the case of untreated samples the full wettability of surface is observed already after 18 months of weathering. The treated samples showed decreasing trend of surface wettability related to degradation of coatings themselves. However, after 36 months of weathering, they still maintain relatively good wettability.

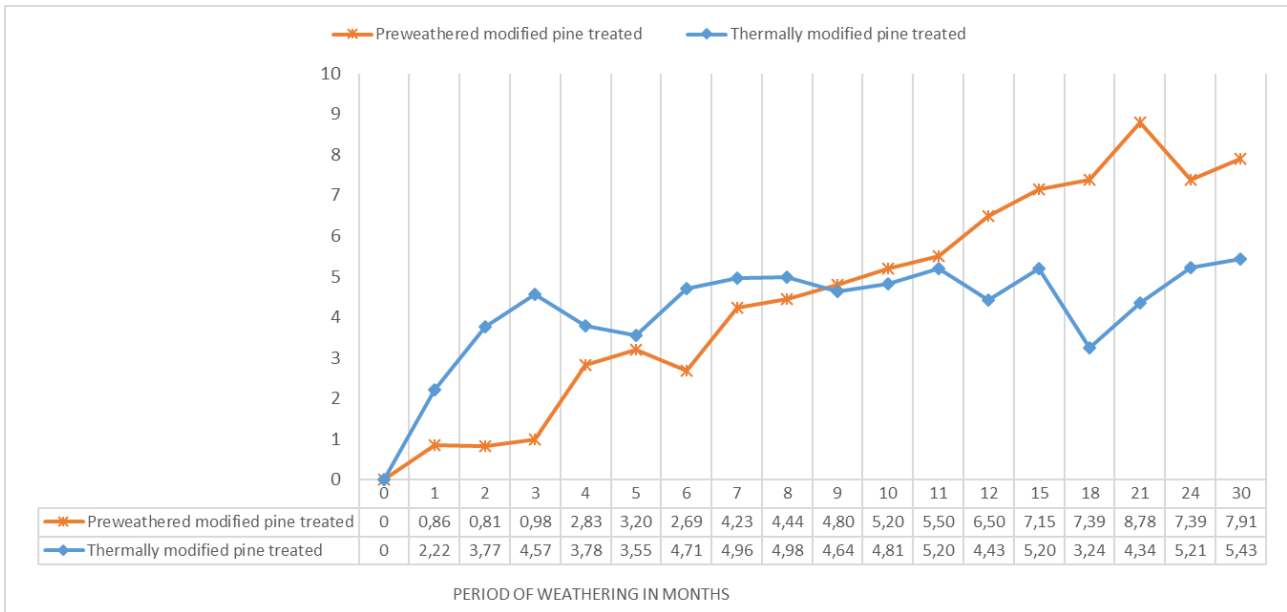
Figure 12: Total colour difference of thermally modified pine (pre-weathered before application of coating and standard) during 30 months of exposure

The graph above shows the total colour difference of pre-weathered thermally modified treated pine in comparison with standard application of coating (Figure 12). We can observe the slower degradation of pre-weathered pine in the initial phase of weathering. After 1 year of outdoor exposure, the pre-weathered pine showed higher colour changes increasing with longer exposure.
